# FISH SURVIVAL IN THE TURBULENT® HYDRO TURBINE AT DENVER SLUICE

A THEORETICAL STUDY BASED ON NEN 8775  
COMMISSIONED BY ENVIRONMENT AGENCY (UK)

Status report : final  
Date report : 04-03-2022  
Author : Dr. B.P.M. van Esch

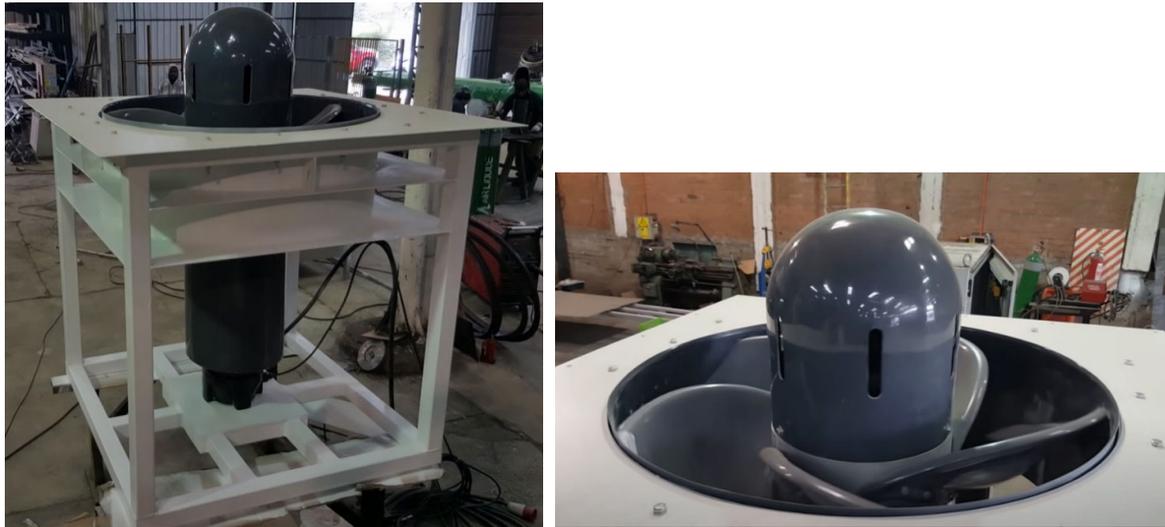
Figure 1: Five-bladed runner of the axial-flow Turbulent hydro turbine [YouTube: gY3p2e1-kN4]

The purpose of this study is to assess the survival rate of fish and eel passing through a Turbulent® hydro turbine designed for low head power generation. The turbine is of axial-flow, propeller type and has five blades with a backward-curved leading edge profile (figure 1). The runner is shrouded with a cylindrical metal plate that covers the full axial extent of the blades.

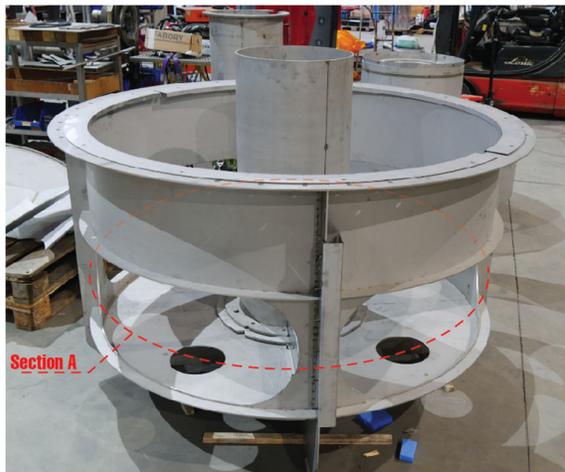
Figure 9: Rubber protective layer onto the edges of the side holes of the cradle

Turbulent decided to add a rubber protective layer onto these edges thick enough to prevent cuts (figure 9).
